## Black HDPE → Natural HDPE Colour Change & Decarbonisation on 8 ltr Accumulator

### The Process

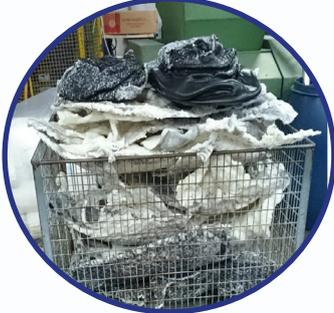
The majority of the colour was gone in 60 kg; large quantity of carbon coming out from the inside-outside line with black as well, proving that the colour was seeping in the carbon cracks

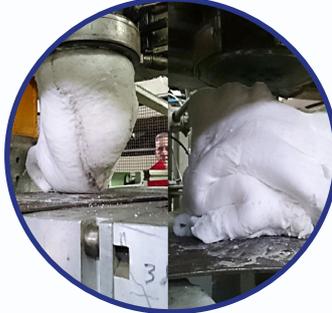
By the end of 100 kg the majority of the carbon was gone ( Left).  
Last full stroke shows no more residue of carbon/colour (Right).  
Machine is switched off for ddecarbonisation

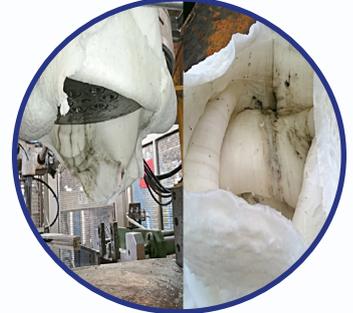
The photos show the build-up of carbon on the inside being removed by the decarbonising, on set up on Monday morning

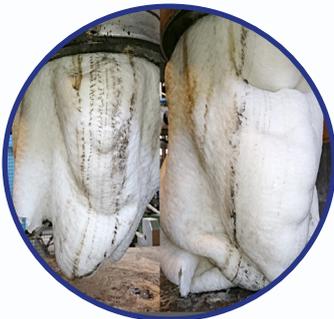
Decarbonising of the outside. Large amount of carbon coming out.

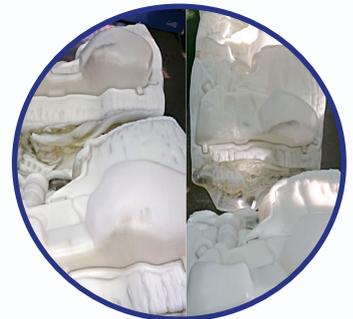
First shot with a black shadow. Second shot with the shadow drastically removed.
